RE: Underground Storage Tank Removal Site Assessment Report

Former American Tissue Stack Site

1 Park Street

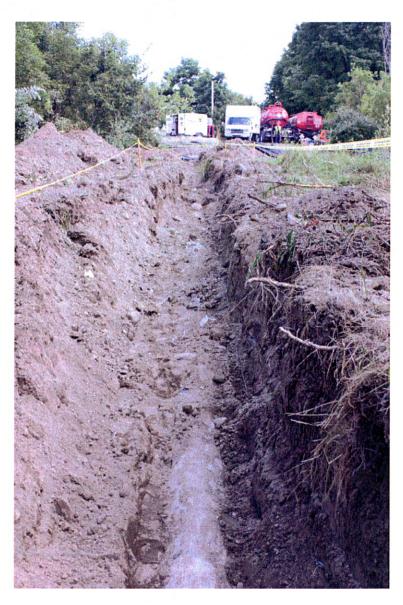
Photo 1- Pipeline alignment from 90 degree bend to pumphouse

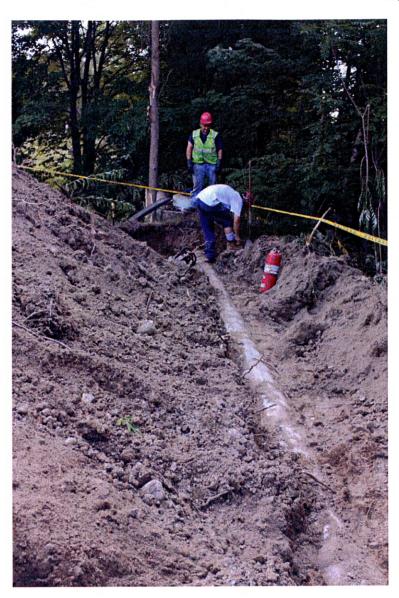
Photo 2- Pipeline alignment from 90 degree bend to manhole

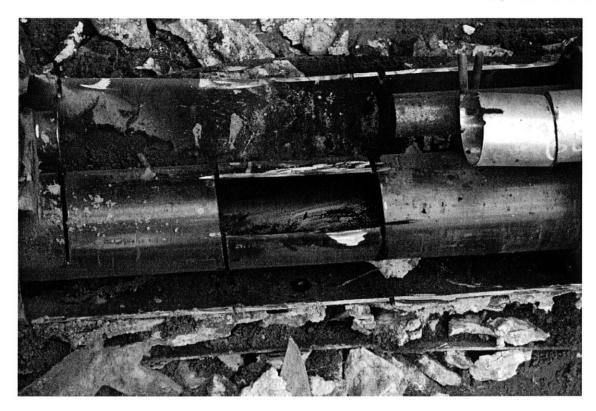
Product piping associated with the UST was observed to be in good condition. No product was observed in the piping. Piping was cut and removed by Cyn Environmental.

Photo 3- The inside of the pipeline after cleaning

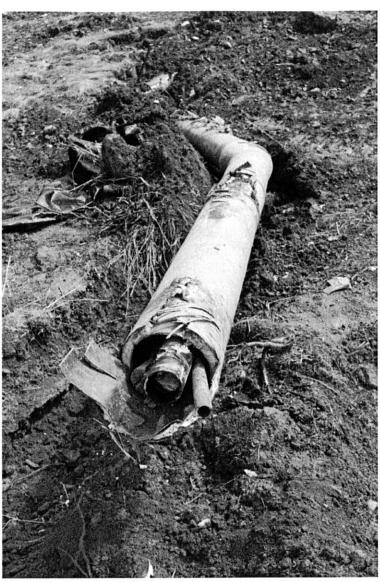
Photo 4- Gravity and return pipelines with in conduit

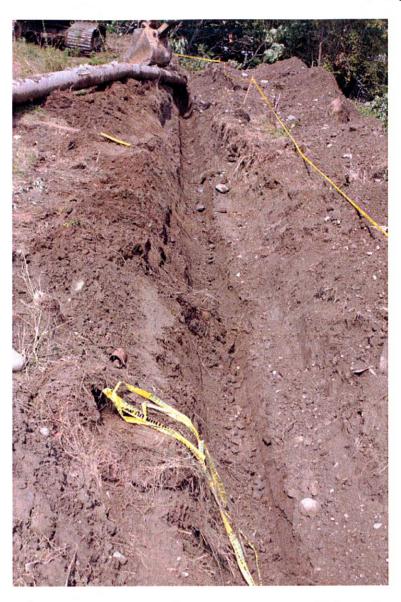
1040- Bob Moore (BM) of Cyn Env. arrived on site with Rich Bell (RB), Cyn Env.'s company manager, to check operations. BG began to pull the pipeline from the ground. There was no visible oil in the soil beneath the line. EM and SV continued to clean the tank by adding diesel fuel to the #6 oil to thin it, and then vacuuming the product from the tank.

Photo 5- Soil Beneath the pipeline after removal. No stained soil was observed.

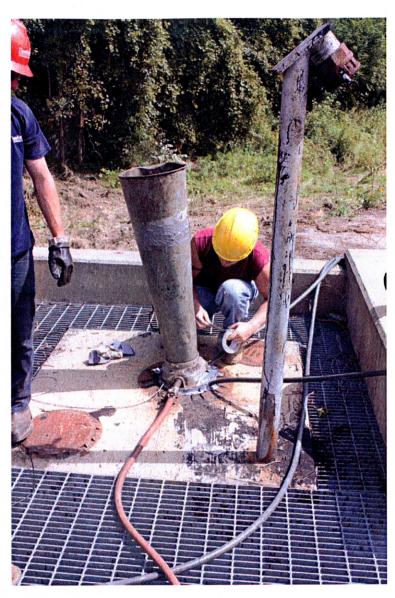
Photo 6- Installation of the ventilation system to the tank before entry for cleaning

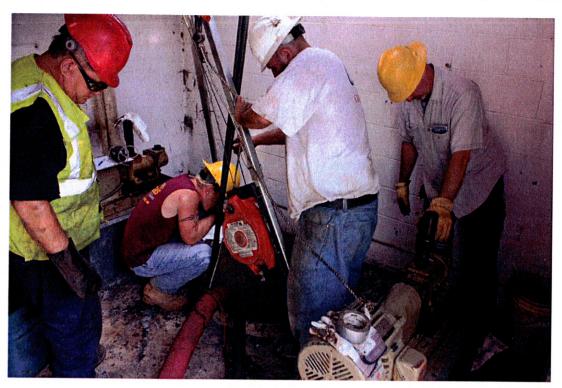
Photo 7- Monitoring the entrance to the tank during cleaning.

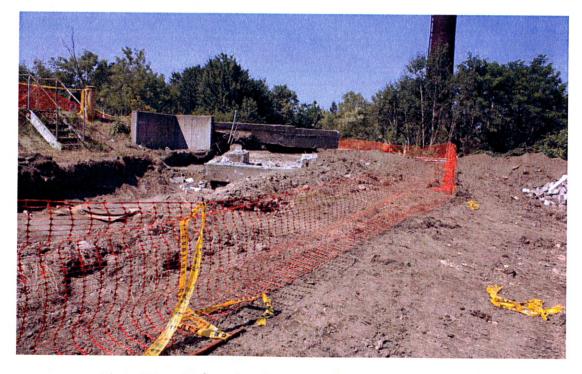
Photo 8- Security fence installed at the perimeter of the excavation

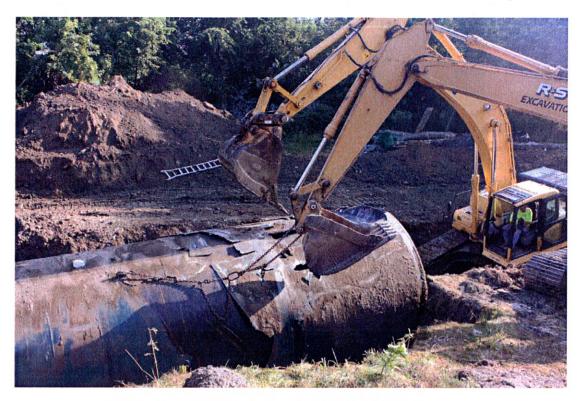
Photo 9- Excavators removing the tank

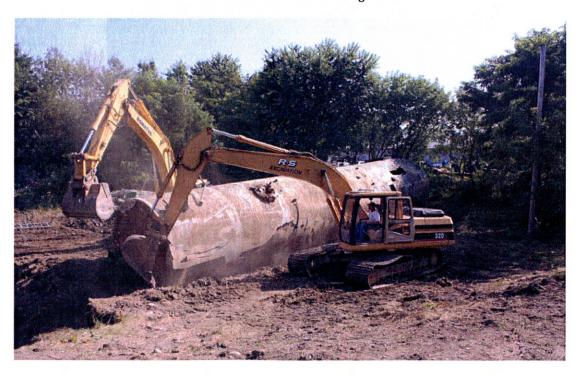
during excavation. Summit observed the UST to be in good condition upon removal with no visible cracks or holes.

Photo 10- Tank removal

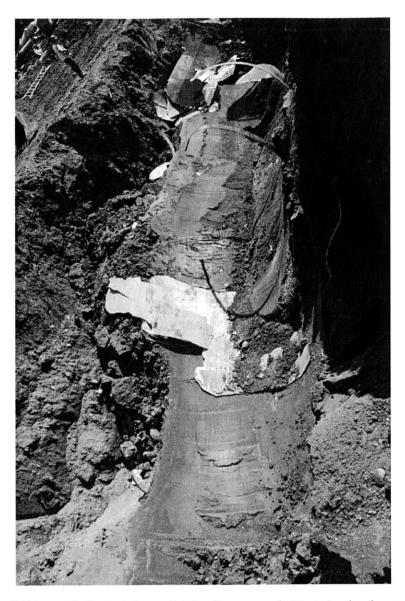
1025- Bob Moore (BM) of Cyn Env. arrived on site. Cyn Env. placed a pipe on the down-hill side of the tank to stabilize it. JF continued to insist that a PID is not necessary, but a visual inspection is. GB conducted a visual inspection of the soil beneath the tank, and determined that no further action is

Photo 11 - Soil beneath the tank immediately after removal. No stained soil was observed.

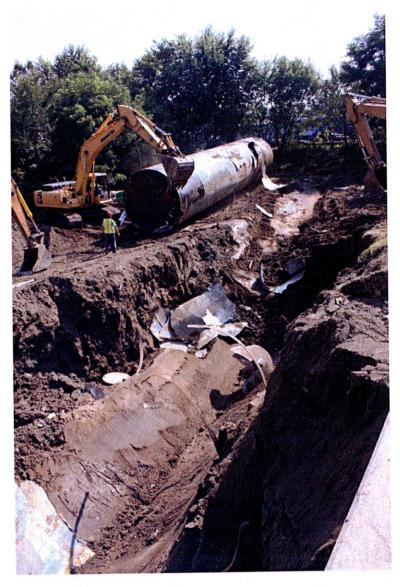
Photo 12- Soil beneath the tank immediately after removal. No stained soil was observed.

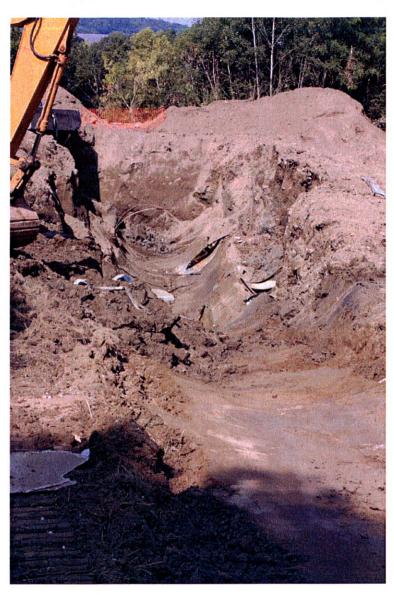
Photo 13 - Soil beneath the tank and along the path of removal. No stained soil was observed.

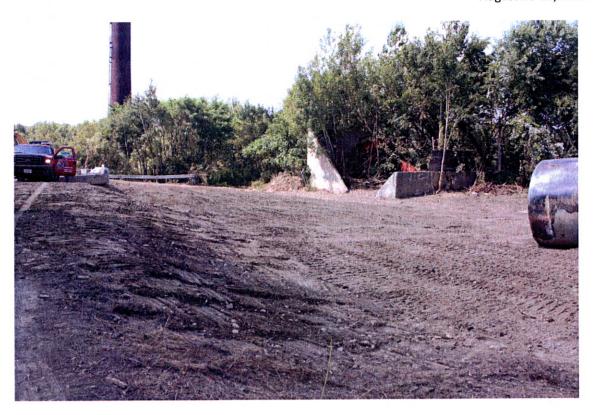
Photo 14- Site regraded after completion of UST removal.
